Chris Home Inspection

Report: ChrisHILLC Report **Address:** 123 Main Terrace

July 17, 2016

RE: 123 Main Terrace
Friendly Town, CA 95123

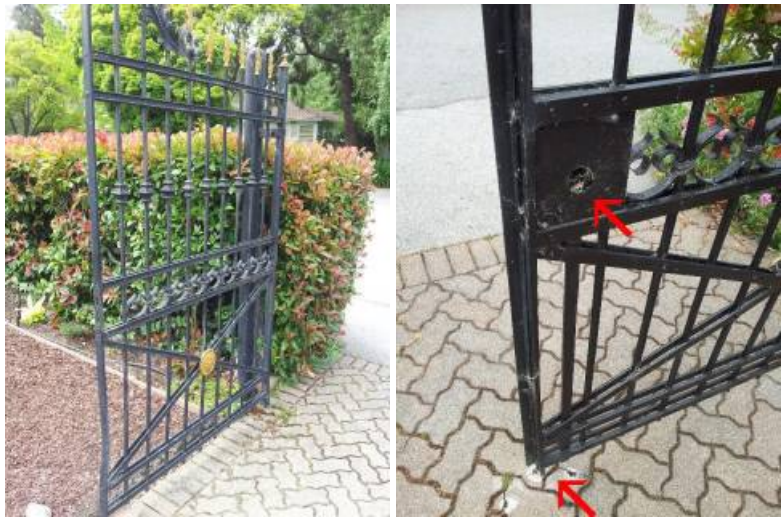
Fences and gates are not a part of this inspection. The gate latch mechanism and lower securing bolts require repair. Comments included as a courtesy.

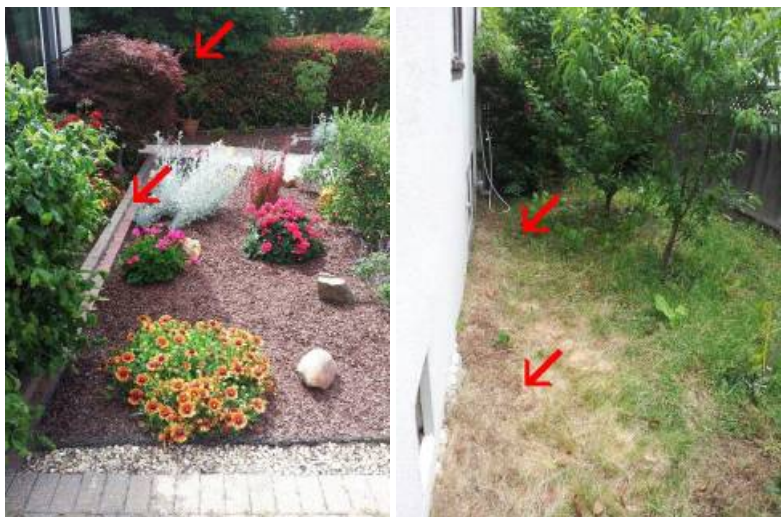
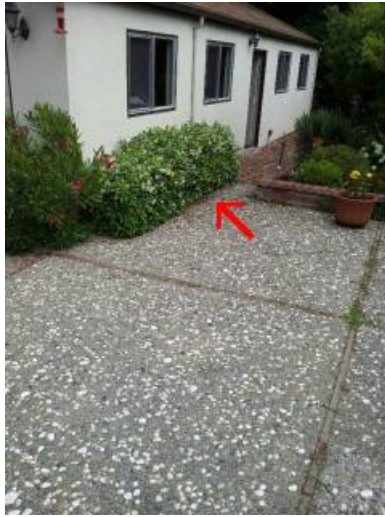
The grade at the front and right sides slope toward the home, and the rear patio area slopes toward the garage. Underground drainage noted on one or more downspouts. Recommend periodic monitoring for any impact on the foundation and possible additional drainage actions.

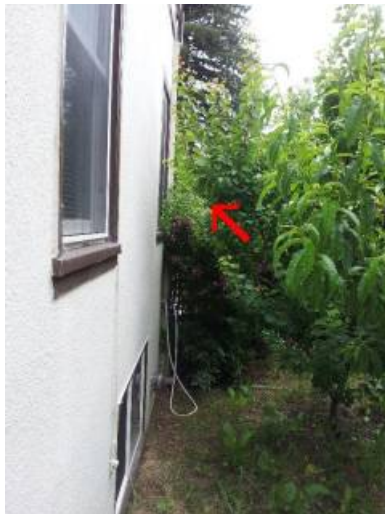
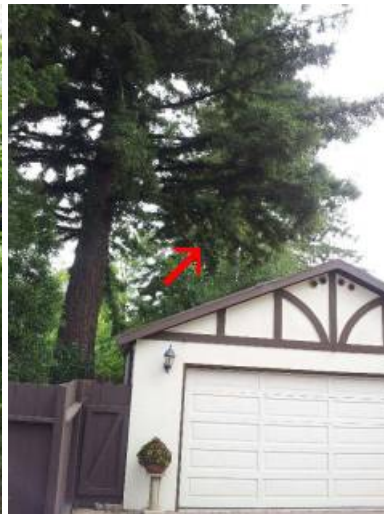
Recommend periodic trimming of vegetation. Right rear, over the garage, and at the front of the garage currently required.

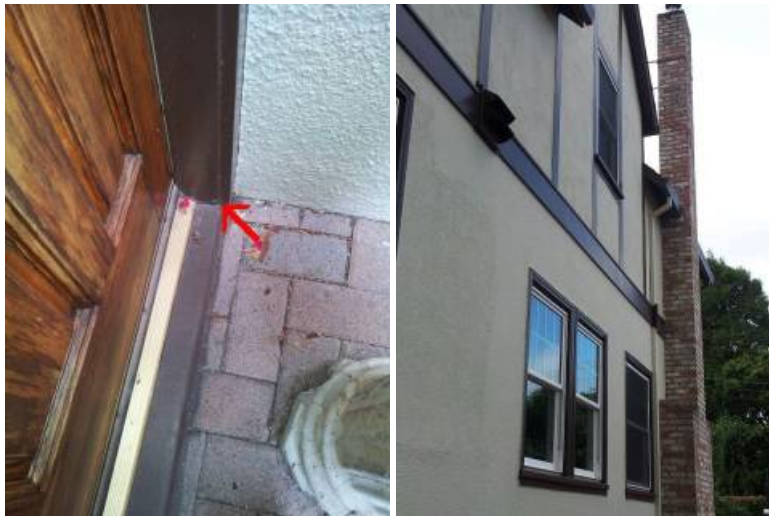
Minor deterioration noted at the front door. See Termite report for additional information. Recommend engaging a skilled tradesperson to effect repairs.

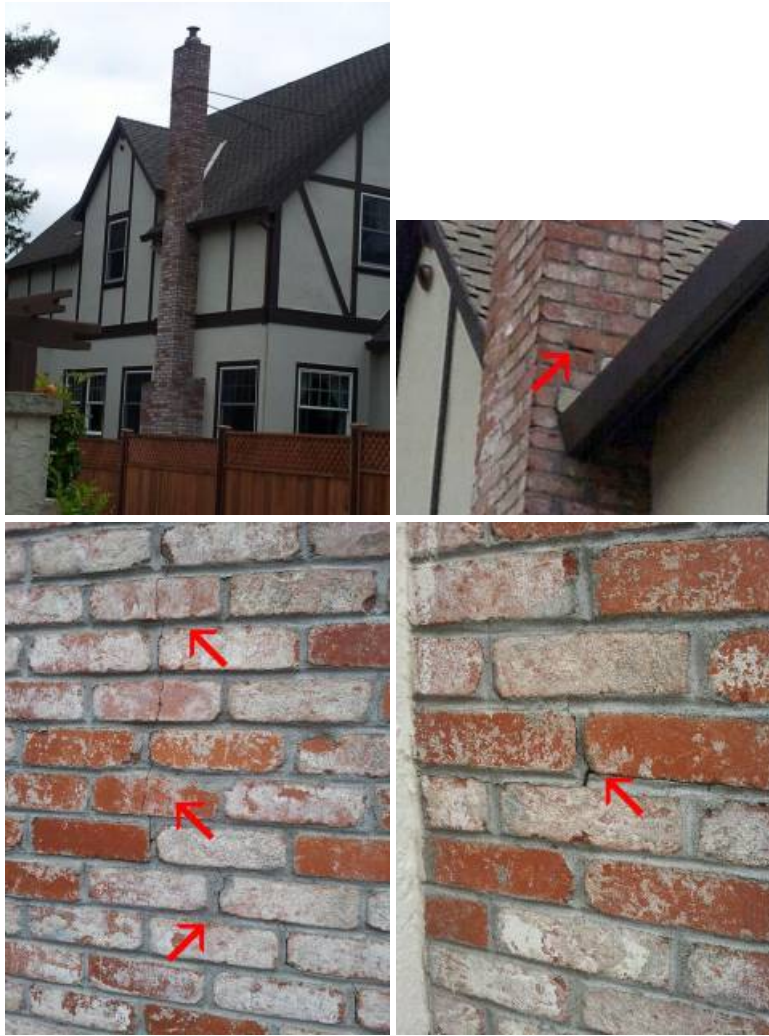
One or more areas of deteriorated grout were observed and hair line cracks noted. Further evaluation and repair is recommended. Recommend engaging a licensed Chimney sweep to further evaluate and provide required repairs.

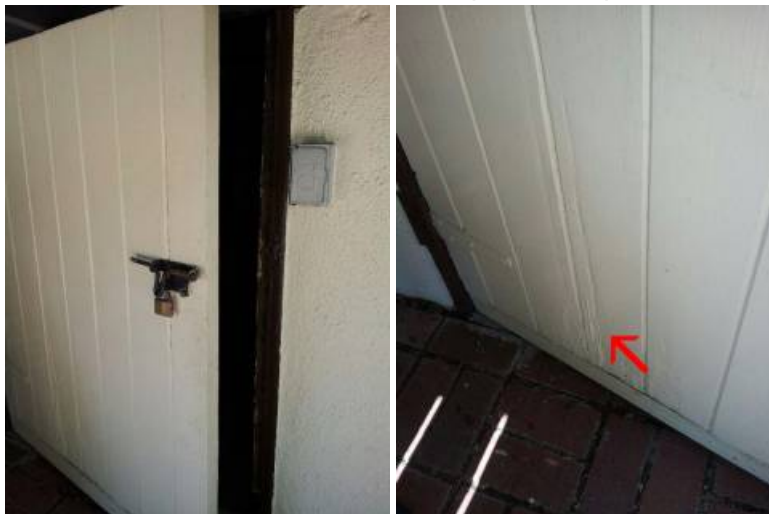
Deterioration noted on the basement access door. See Termite Report for further information. Recommend engaging a skilled tradesperson to repair as required.

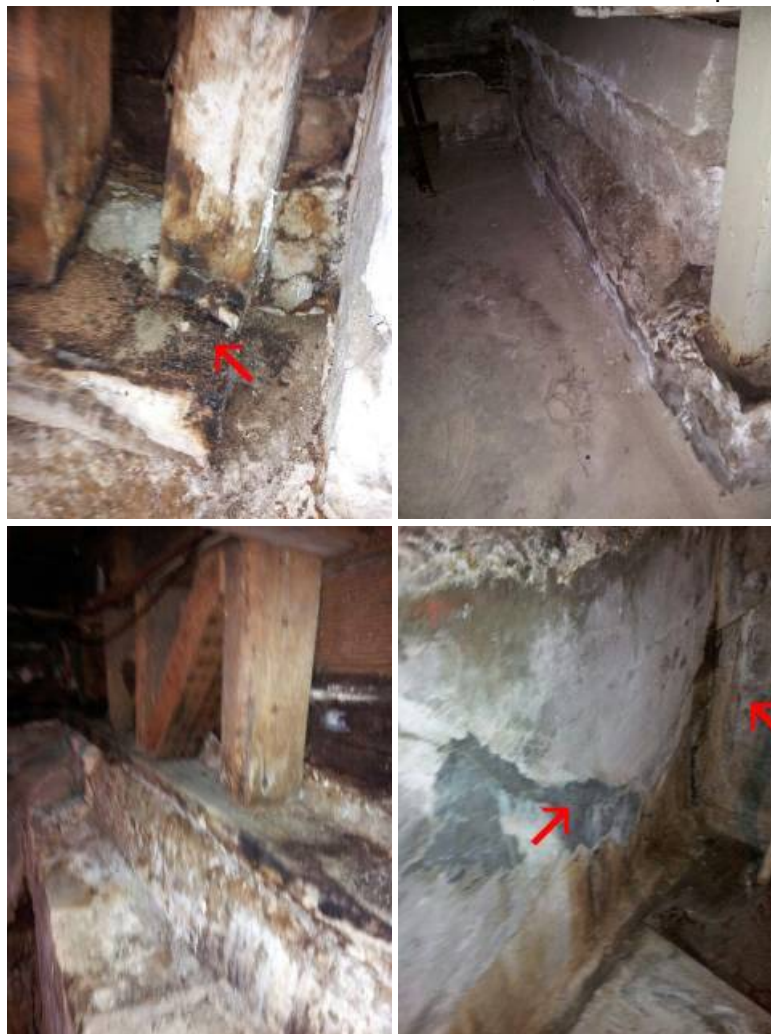
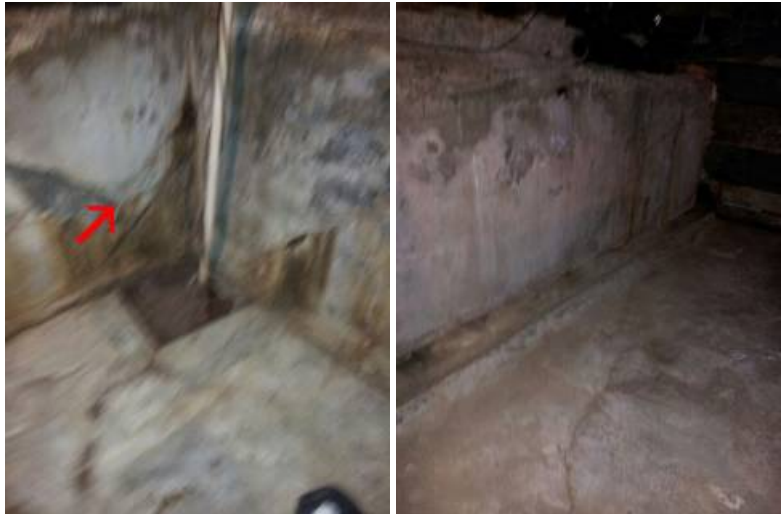
Small cracks noted at the right front corner, near the sump pit, with some protrusion inward, and on the floor in this area. Small cracks noted further inward in this area. Deterioration noted in the cripple wall in this area. See Termite Report for further information. Recommend engaging a licensed contractor to further evaluate these issues, make and implement recommendations.

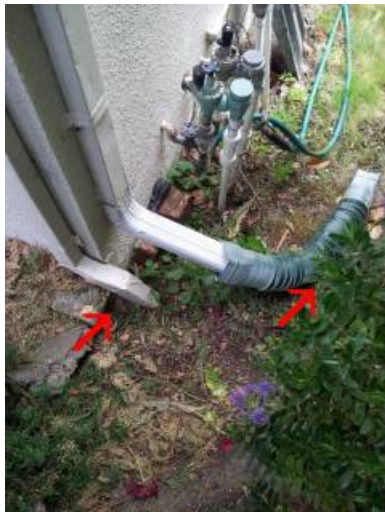
Other downspouts terminate at the foundation, and at the vicinity of the underground system. Recommend engaging a skilled tradesperson to evaluate the possibility of routing these downspouts into the underground system.

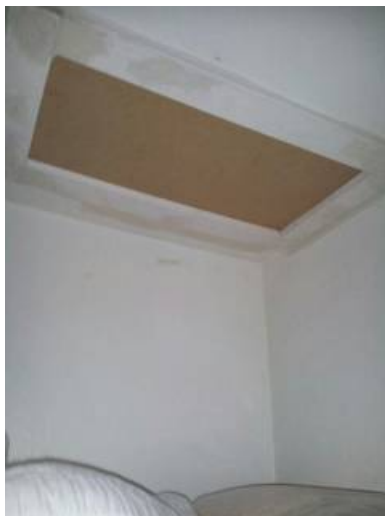
It was noted the springs on the access ladder for the garage did not have safety wires installed. As a safety upgrade, recommend installation by a skilled tradesperson.

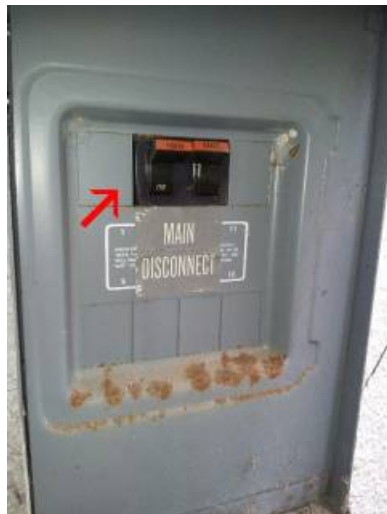
It was noted that this panel is a Federal Pacific Electric panel. There have been recalls for this type of panel due to overheating. This is a safety concern. Recommend engaging a licensed Electrician to further evaluate, make recommendations and implement repairs as required.

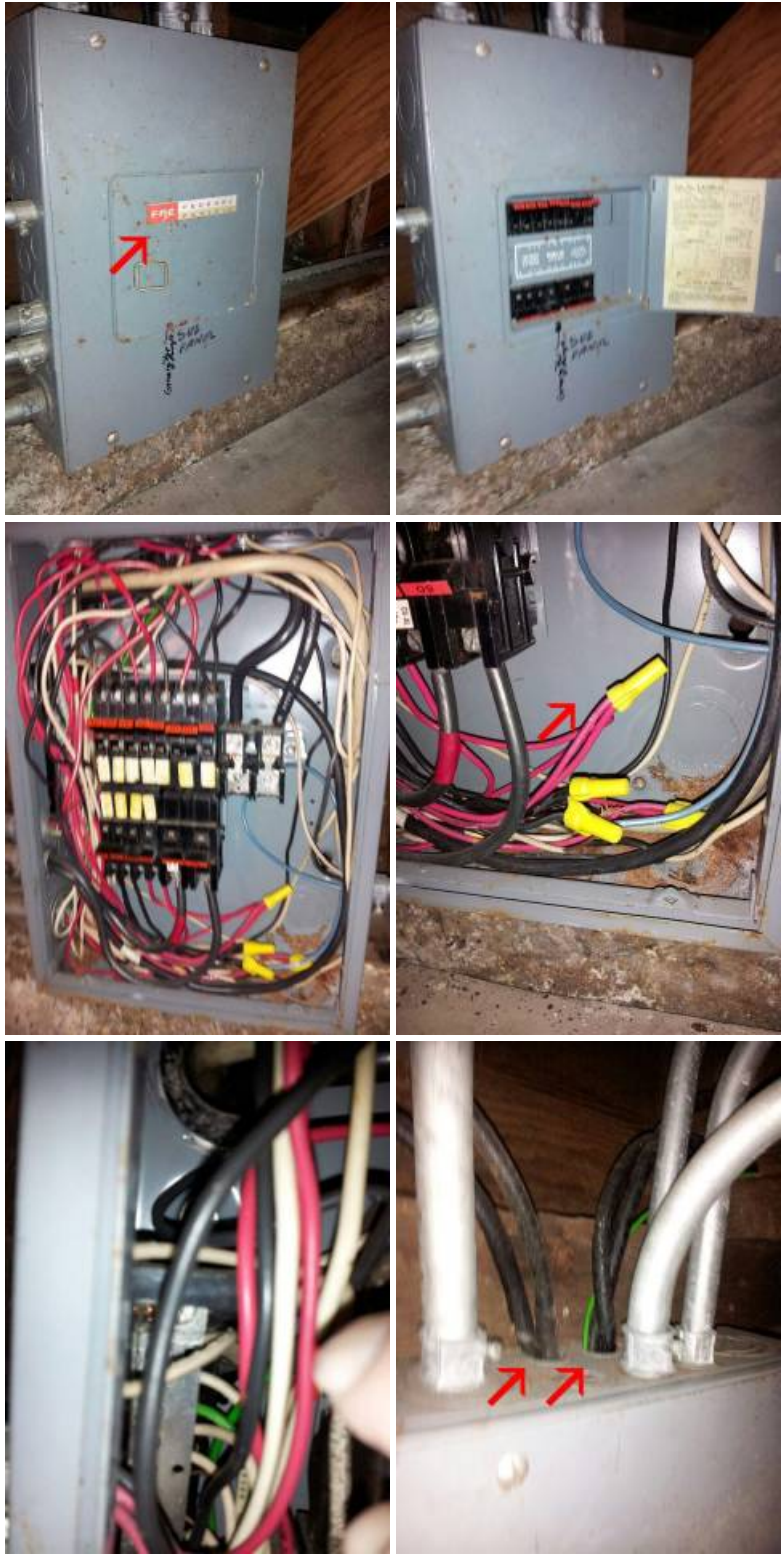
Other concerns were noted in this panel. The ground and neutral wires were connected to the same bar, older wiring observed apparently routed to knob and tube wiring, and wire twists were not taped. These are safety concerns as well. Recommend engaging a Licensed Electrician to further evaluate, make and implement recommendations.

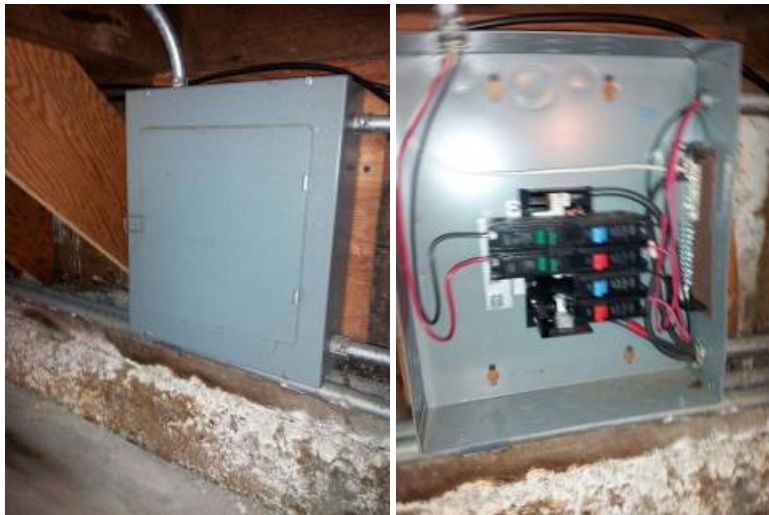
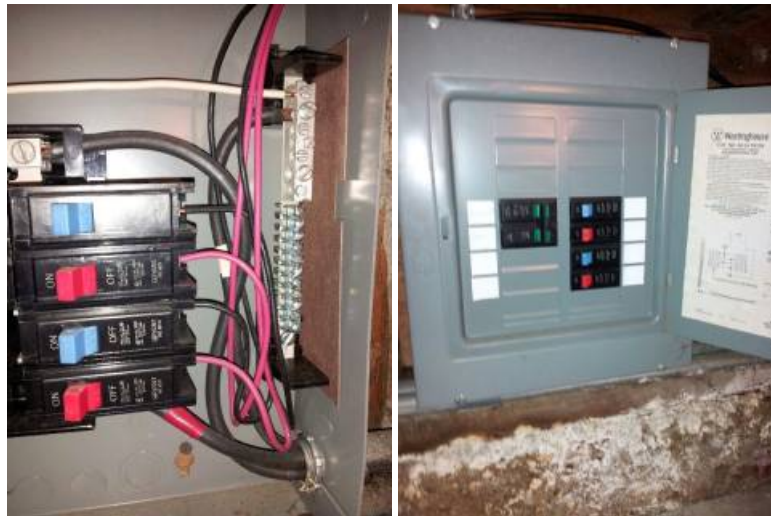
Subpanel #2:

The 30 amp wires appear undersized and there was no evidence of a ground bar. These are a safety concern. Recommend engaging a Licensed Electrician to further evaluate, make recommendations and implement repairs.

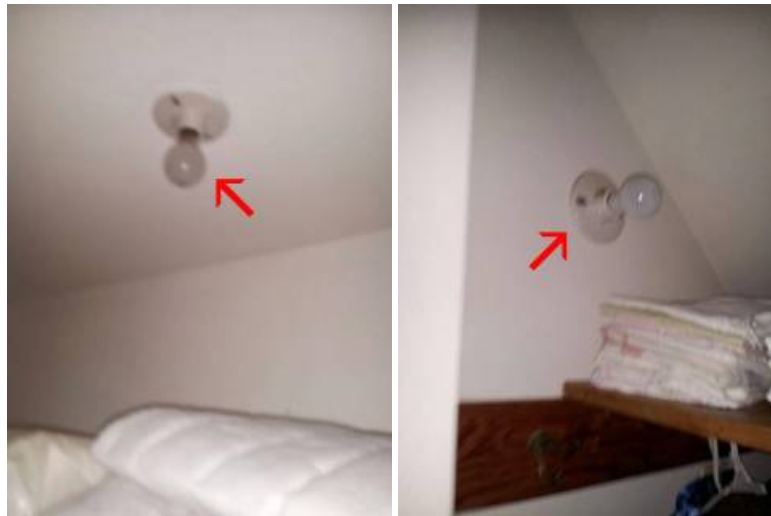
Globes were missing from one or more closet lights. Recommend engaging a skilled tradesperson to install globes to eliminate a fire hazard.

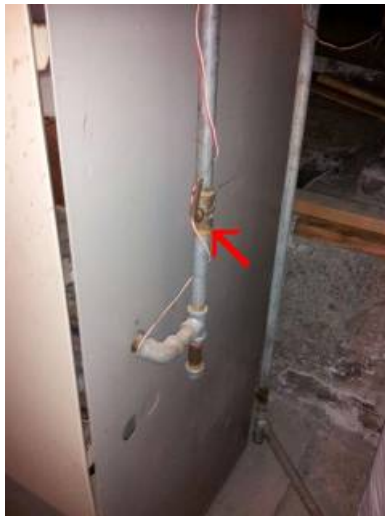
It was noted that there was no flexible gas line installed. As a seismic safety upgrade, installation is recommended. Recommend engaging a Licensed HVAC contractor to install.

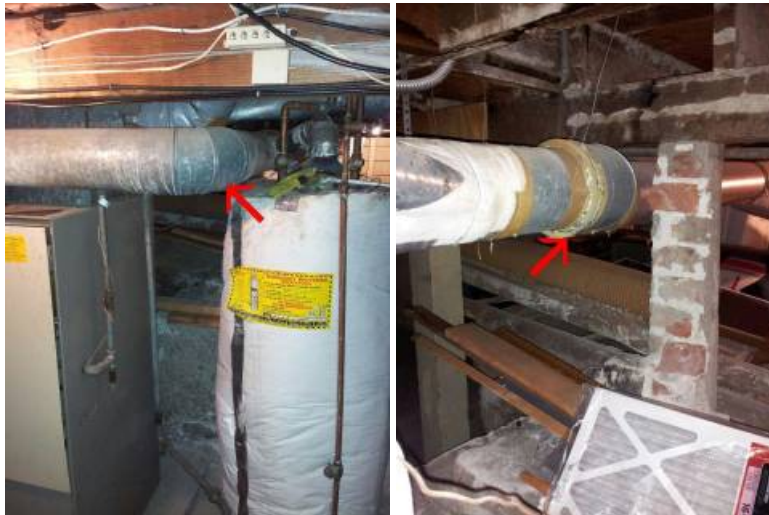
It was noted that the flue is improperly routed as it does not slope upward at 1/4" per foot. This is a safety concern. Recommend engaging a licensed HVAC contractor to repair as required.

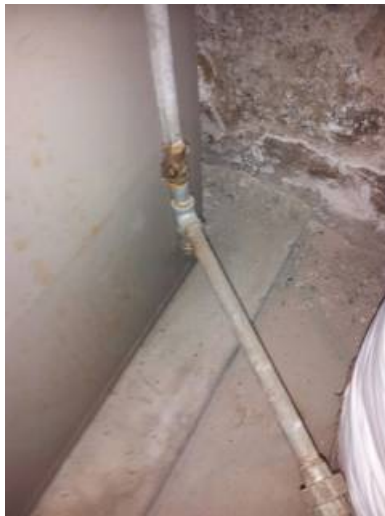
It was noted that there was no flexible gas line installed. As a seismic safety upgrade, installation is recommended. Recommend engaging a Licensed Plumber to install.

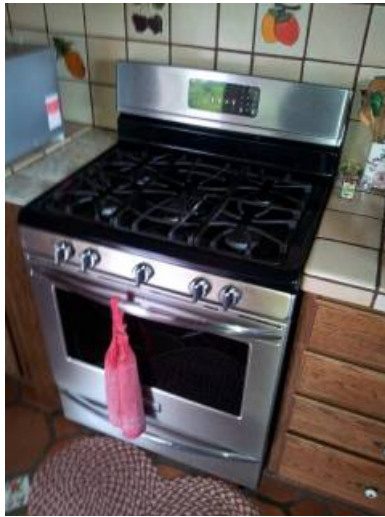
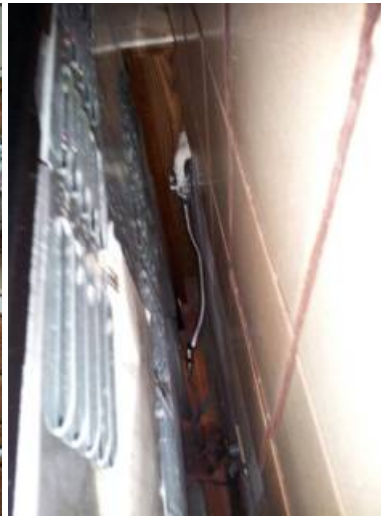
No anti tilt bracket was installed to prevent accidental tipping. A gas shutoff valve was not present. As a safety upgrade, recommend installing these components. Recommend engaging a skilled tradesperson & plumber to install.

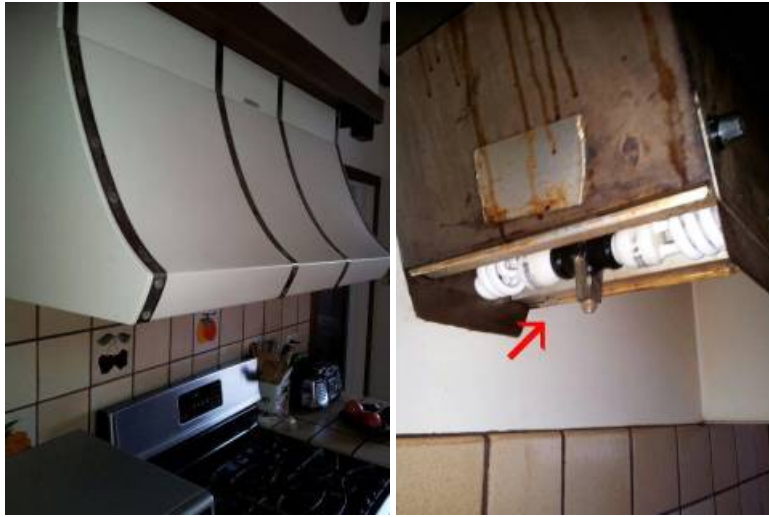
The light cover was missing, exposing the interior. Recommend engaging a skilled tradesperson to replace the cover.

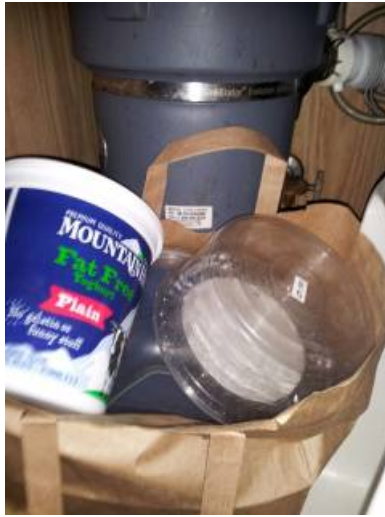
The garbage disposal did not operate. Recommend engaging a skilled tradesperson to repair as required. The owner commented a Plumber was scheduled for repair the day following the inspection.

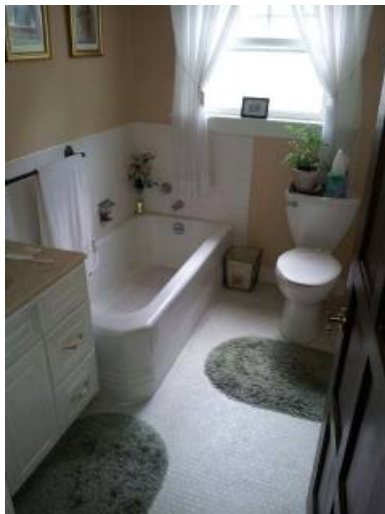
The first floor sink drained slowly. Recommend engaging a skilled tradesperson to repair as required. The owner advised a Plumber was scheduled the day following the inspection.

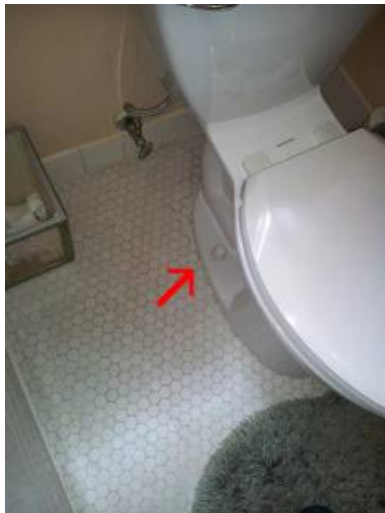
The toilets flushed appropriately. Both toilets were loose. Leakage below the floor was not determined. Recommend engaging a skilled tradesperson to secure as required. The owner advised a Plumber was scheduled the day following the inspection.

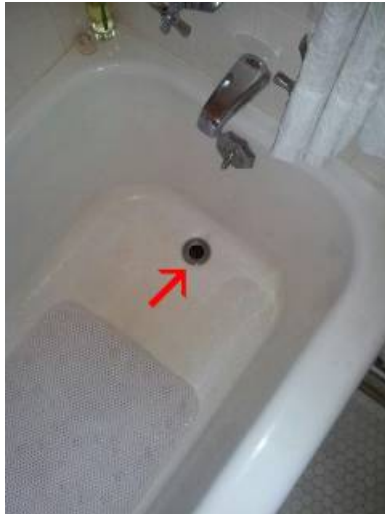
The tub/shower fixtures appear serviceable. First floor tub drained slowly. Recommend engaging a skilled tradesperson to clear as needed. The owner advised a Plumber was scheduled the day following the inspection.

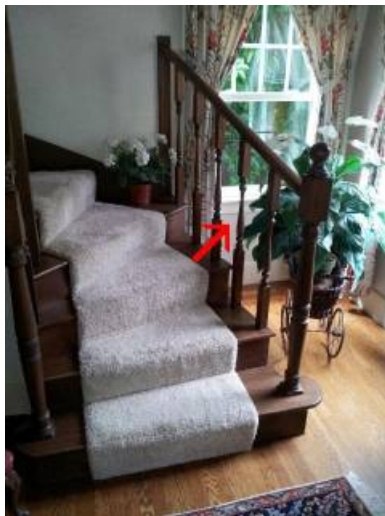
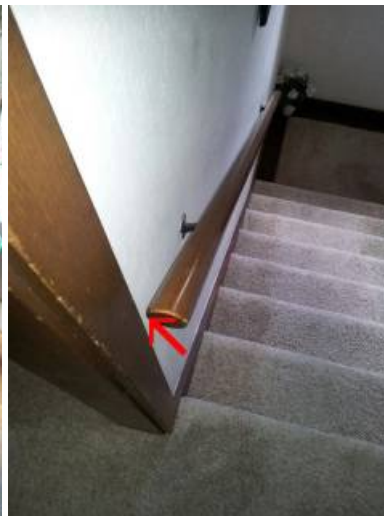
The stairs and handrails were secure, however, do not meet current recommendations for baluster spacing and closed handrails. As a safety upgrade, recommend considering retrofitting to meet current requirements. Recommend engaging a skilled tradesperson to further evaluate make recommendations and implement.

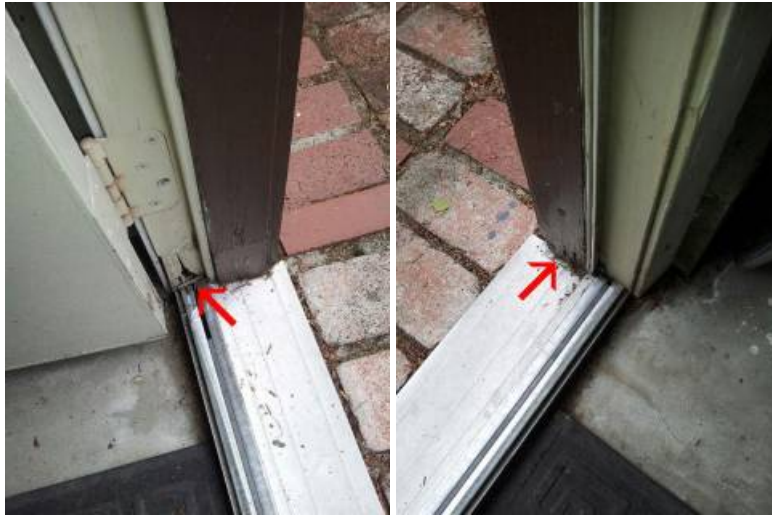
Deterioration noted at the jamb. See Termite report for more information. Recommend engaging a skilled tradesperson to repair as needed.
