Confidential Inspection Report

November XX, 2010

RE: 123 Main St.
Any Town, CA 95XXX

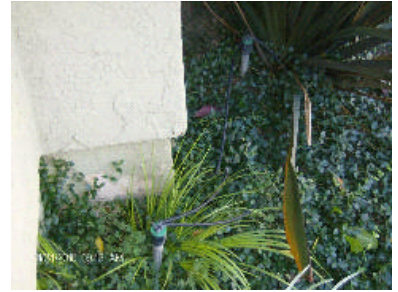
Sprinkler heads too close to home. Should be 18" away. Appear to be bubbler type that may mitigate the issue.

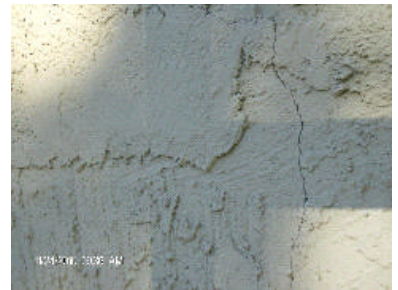
Walls are constructed with: Stucco, Cracks noted are typical, But bear monitoring. Suggest sealing identified cracks, noted in rear west side.

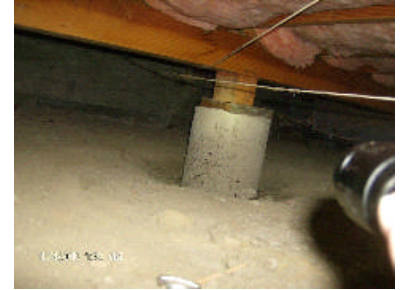
There were no elevated moisture levels noted on the exposed areas of the crawlspace walls, and there was no evidence of moisture throughout the area.

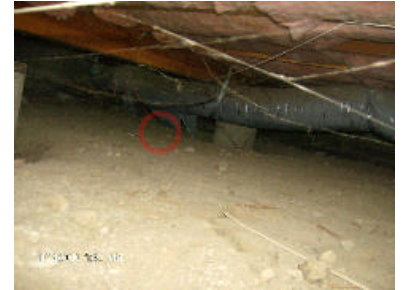
Satisfactory - The cross-ventilation in the crawlspace appears to be adequate. One ventilation duct has some torn exterior covering hanging. When possible, repair is encouraged. Location east wall near front of home.

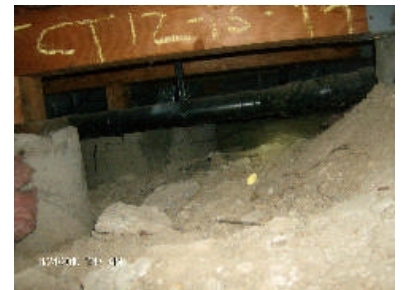
Exposed concrete piers at least 8" in diameter are visible in the crawlspace. The piers as installed appear to be adequate. No engineering analysis was completed. One large pier was noted under the kitchen area.

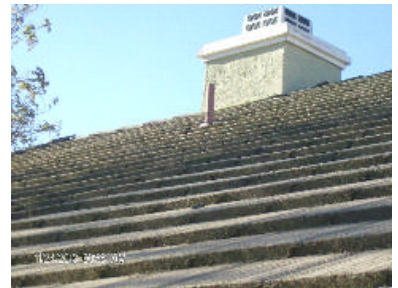
Tile. Appears serviceable/within useful life.

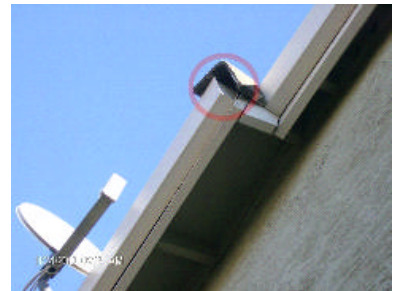
Numerous end tiles partially detached from roof and present serious hazard and potential injury should they fall.
Recommend they all be secured by qualified contractor.

. p p
 Numerous end tiles partially detached from roof and present serious hazard and potential injury should they fall. Recommend they all be secured by qualified contractor.

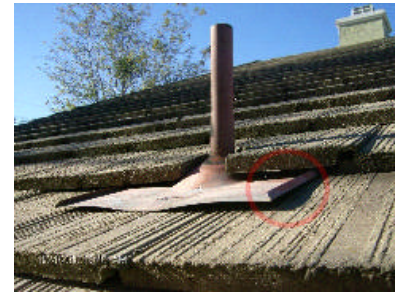
As viewed from roof edge on ladder appeared serviceable. One vent appeared to have excessive gap. Suggest evaluation when roof is inspected by contractor. The potential for water entry is present.

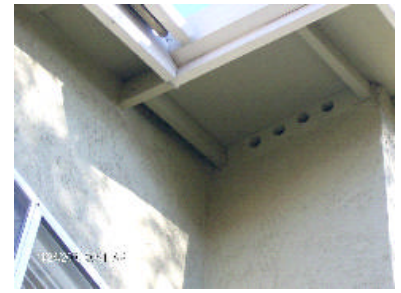
Appear in serviceable condition with no visible deterioration.

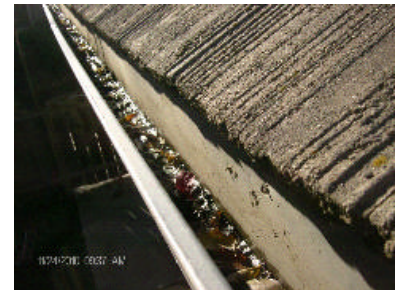
Debris in gutter, should be cleaned.

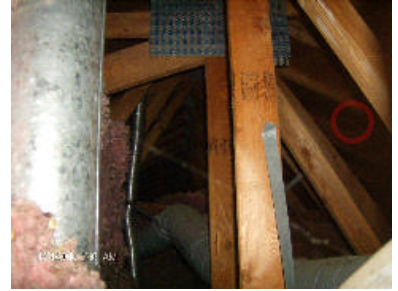
Access: Viewing was limited, to observing from hatch areas only. Access is restricted by low headroom and structural construction.

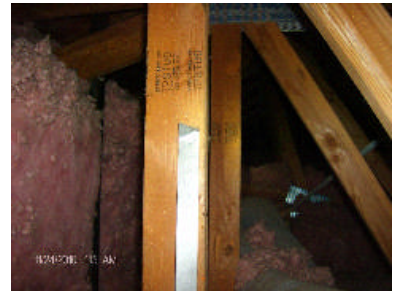
A rafter system is installed in the attic cavity to support the roof decking and appears to be in satisfactory condition. The rafter spacing appears 16 inch on center, but could not be measured. Additional rafter bracing was noted.

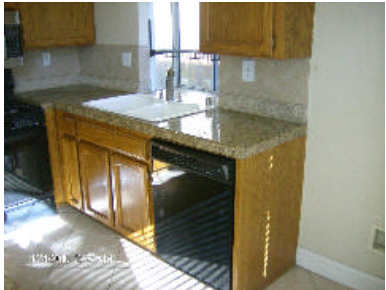
All bath, kitchen outlets adjacent to sinks were tested for GFCI. All were good except for two in kitchen on either side of sink. Ground Fault Circuit Interrupter (GFCI) outlets are recommended for installation at exterior, garage, bath rooms & kitchen outlets. Garage outlets were GFCI protected.

General: " " p p " All bath, kitchen outlets adjacent to sinks were tested for GFCI. All were good except for two in kitchen on either side of sink. Ground Fault Circuit Interrupter

(GFCI) outlets are recommended for installation at exterior, garage, bath rooms & kitchen outlets. Garage outlets were GFCI protected.

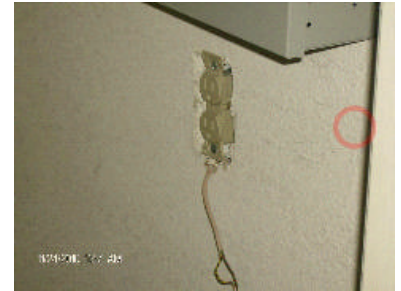
Missing or damaged cover plates viewed. In closet under stairway.

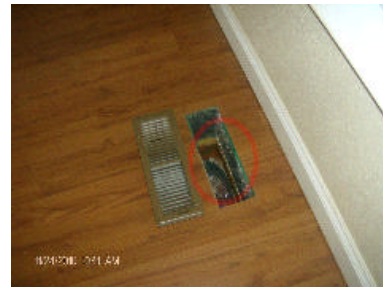
Flexible Round,
Minor re-taping is
needed on one duct
in crawl space.
Registers in living
room are not
secured in place
(floor mounted) and
could cause an
accident if left open.
Suggest
implementing some
means of securing
the registers.

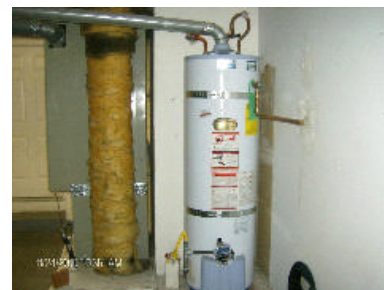
Condition: p Pressure relief valve noted, not tested, Flue vent intact. Unit appears new, typical service life 7-10 years.

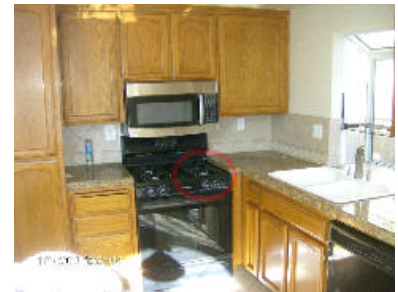
Type & Condition: . . . p Gas, Electric ignition, Right front burner is inoperative. Suggest cleaning of burner to see if that resolves problem. Oven tested to 330 degrees F setting and matches thermometer.

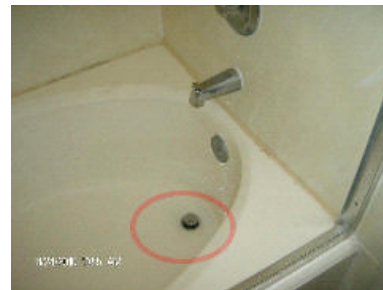
The following problems were noted at the tub/shower drain:
Drain is slow at tub.
Suggest removing drain stopper and inspect for debris, or clean out associated trap.

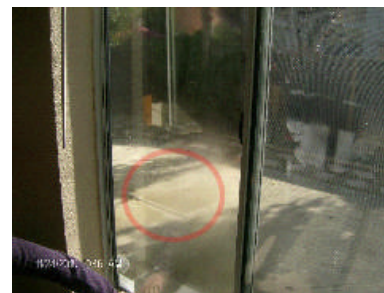
- Kitchen Interior:** At least one window or associated hardware in this room needs repair. The thermal seal is broken. Although it is keeping the elements out, it has a clouded appearance. This condition will worsen.

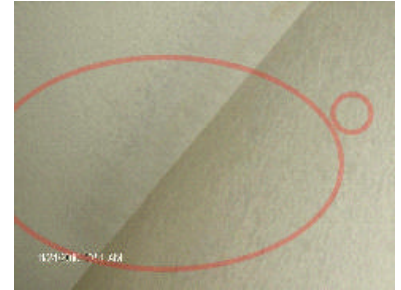
Living Room: Previous Leak - There are signs of a previous water leak in the ceiling in this room. It does not appear to be an active leak.

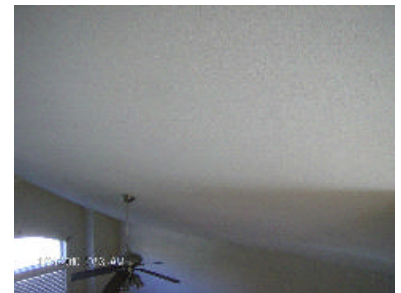
Dining Room: There is a condition in the ceiling that needs attention. There is some minor cracking noted in the living room ceiling observable on the second floor landing. Be sure to take note of any future movement. Most minor cracking is due to shrinkage of the construction materials.

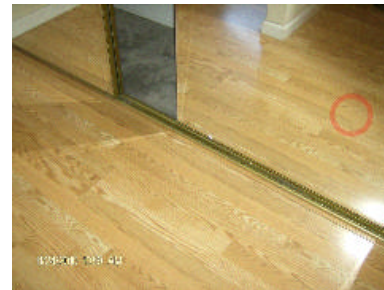
Master Bedroom: The mirror is cracked at the bottom left corner on the closet door and should be replaced.

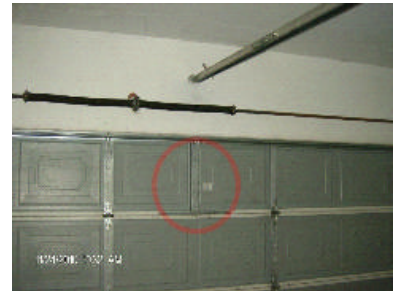
Automatic door opener(s)- not operational. Chain and bracket mechanism missing. Based on size of door automatic opener is recommended to avoid injury.

.. .. p p .. Automatic door opener(s)- not operational. Chain and bracket mechanism missing. Based on size of door automatic opener is recommended to avoid injury.
