Chris Home Inspection

Report: ChrisHILLC Report **Address:** 123 Main Terrace

July 17, 2016

RE: 123 Main Terrace
Friendly Town, CA 95123

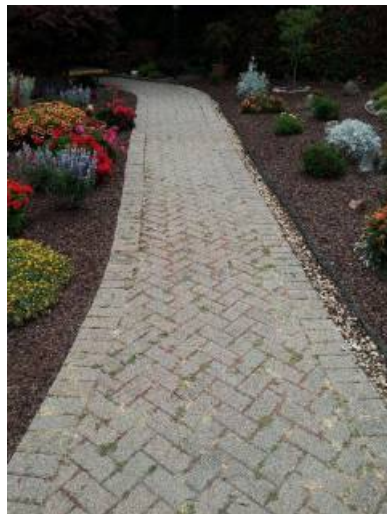
Walks:

Pavingstone path to the front appears serviceable.

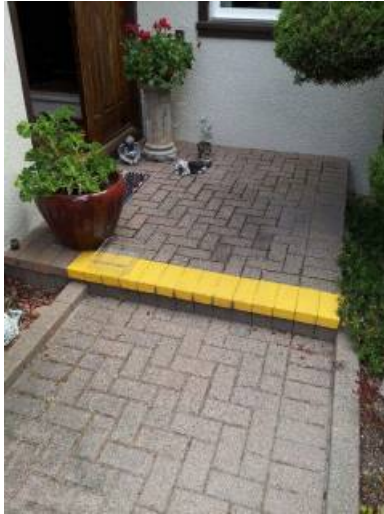
Exterior Steps / Stoops:

Steps at the front appear in serviceable condition.

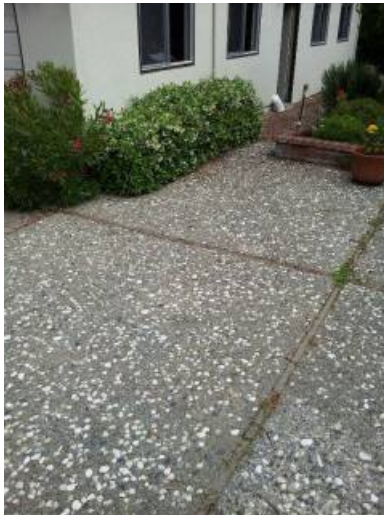
Slab:

Slab appears in serviceable condition.

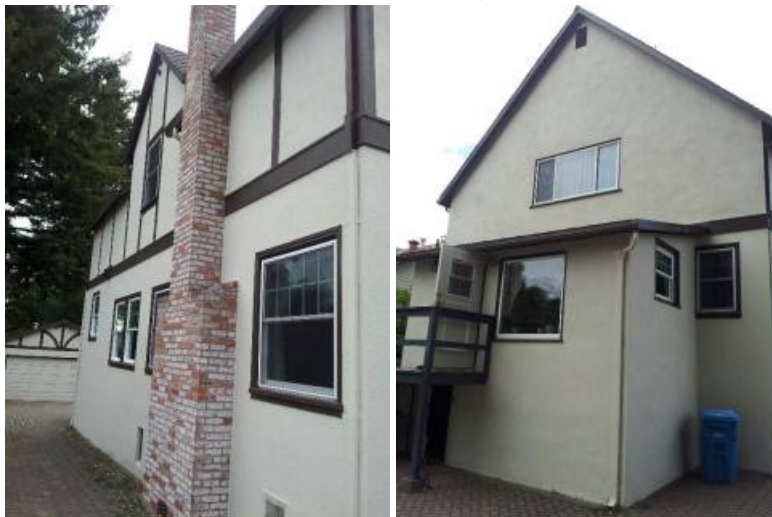
Materials & Condition:

Exterior walls are constructed of stucco, and appear in serviceable condition.

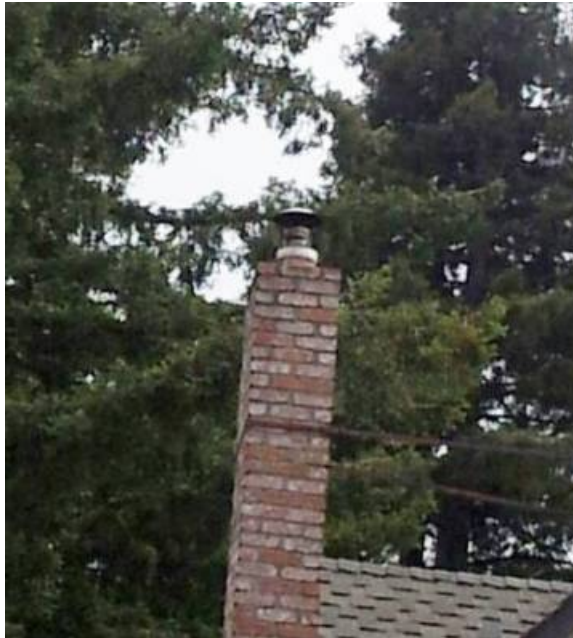
Inspected with binoculars from the ground. A rain hat and spark arrestor were observed. Appears serviceable so far as visible.

OK	MM	RR	SAF	NI	
Flue:	<input type="checkbox"/>	<input type="checkbox"/>	<input type="checkbox"/>	<input type="checkbox"/>	<input checked="" type="checkbox"/>	Not accessible.
Flashing:	<input type="checkbox"/>	<input type="checkbox"/>	<input type="checkbox"/>	<input type="checkbox"/>	<input checked="" type="checkbox"/>	Not visible from the ground.
Chimney Cap:	<input type="checkbox"/>	<input checked="" type="checkbox"/>	<input type="checkbox"/>	<input type="checkbox"/>	<input type="checkbox"/>	Inspected with binoculars from the ground. A rain hat and spark arrestor were observed. Appears serviceable so far as visible.
						Recommend further inspection by a licensed chimney sweep.

Recommend further inspection by a licensed chimney sweep.

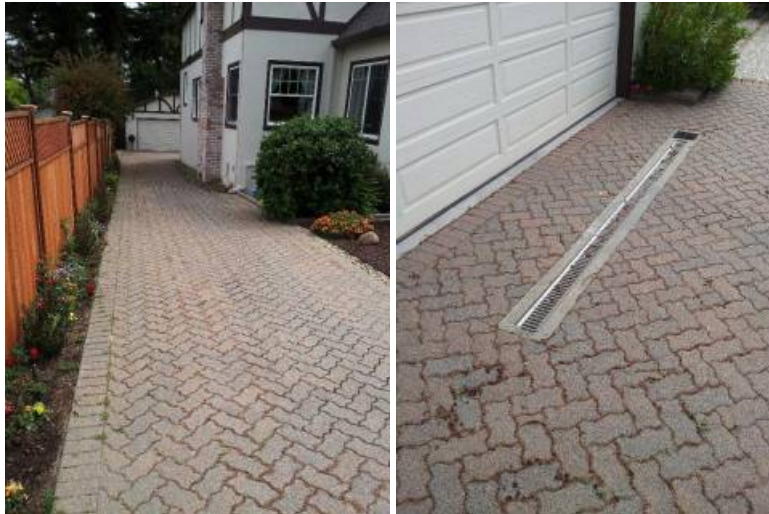
Paving Conditions:

The pavingstone driveway properly slopes away from the home and toward the garage where a drainage trough keeps water away from the garage.

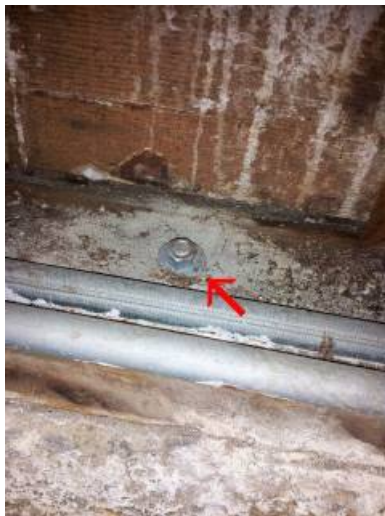
Foundation Bolts:

Evidence of the use of foundation bolts to secure the framing to the foundation was observed.

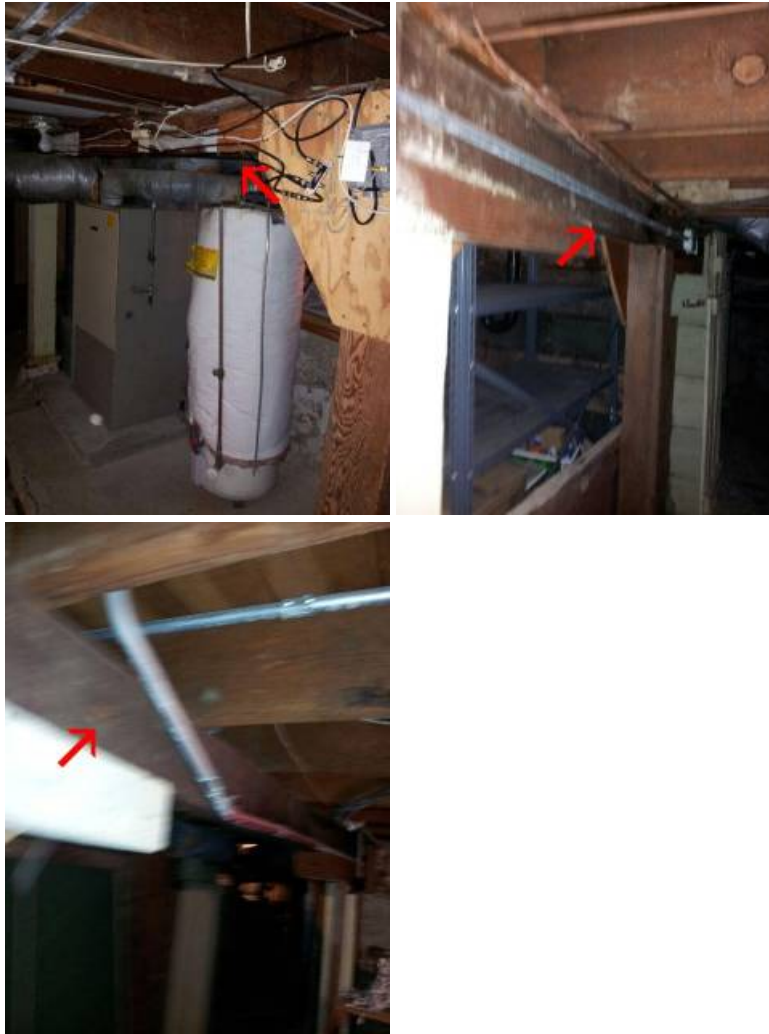
Beams/Underfloor:

The beams and underfloor appear in serviceable condition.

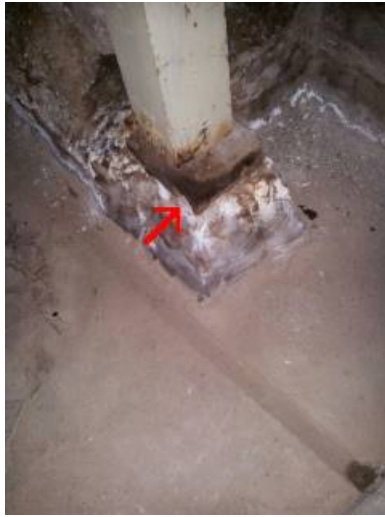
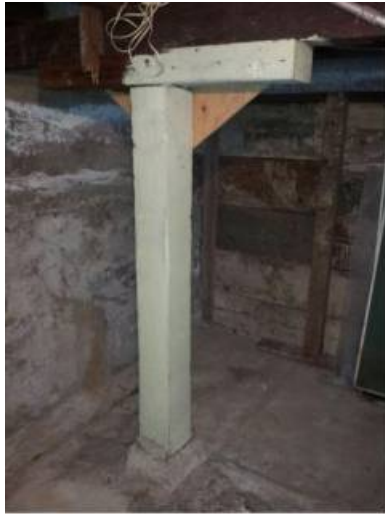
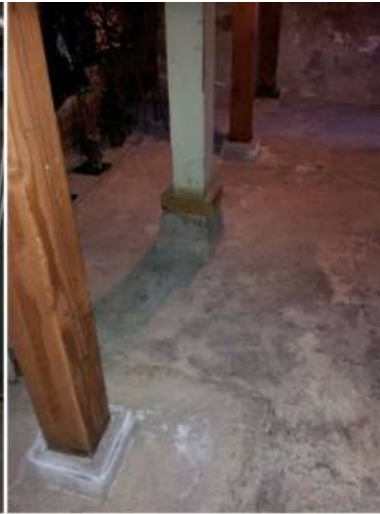
Posts & Piers:

Deterioration and cracks noted on one pier and post near the furnace. Recommend repair to prevent progressive damage. Recommend engaging a licensed contractor to further evaluate, make recommendations and implement repairs.

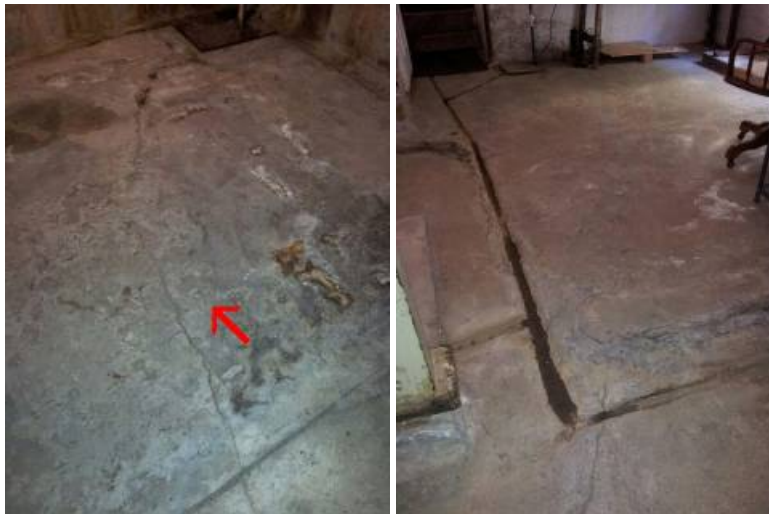
Floor:

Typical crack noted at the right front corner. See remarks in Wall section.

Overall appear serviceable, moisture noted in drainage channel.

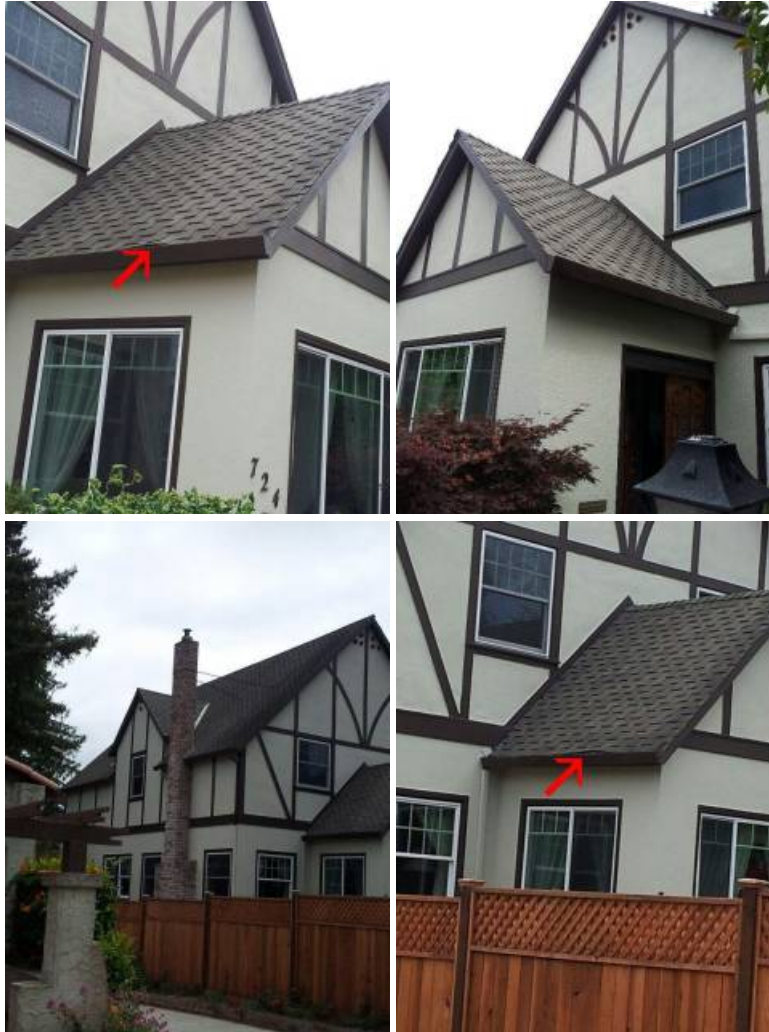
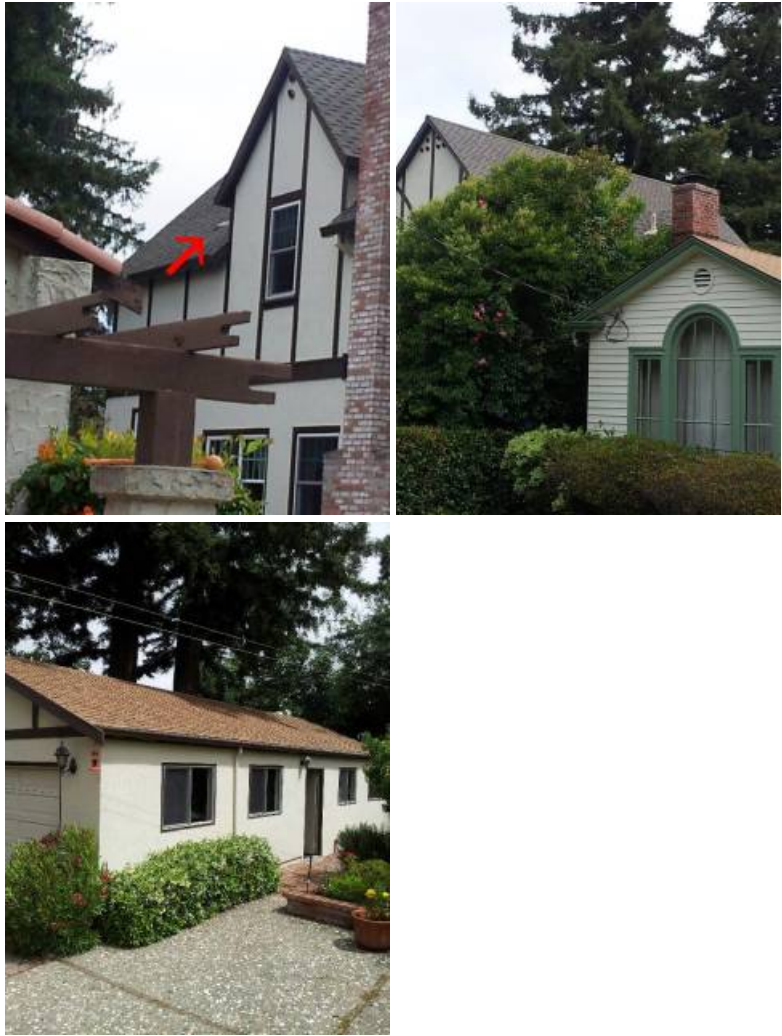
Roof Covering:

Composition shingles. Overall appears serviceable. Two areas on the left appear lifted and should be evaluated by a Roofing contractor.

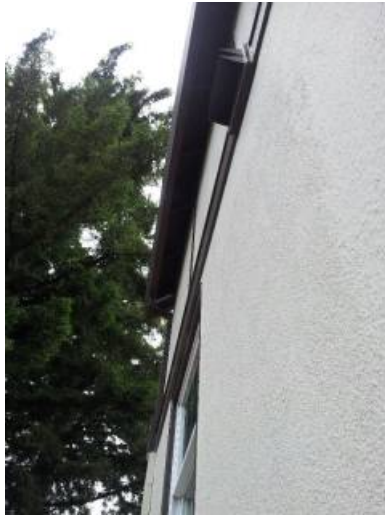
Eaves - Soffits - Fascias:

Appear serviceable so far as visible from the ground.

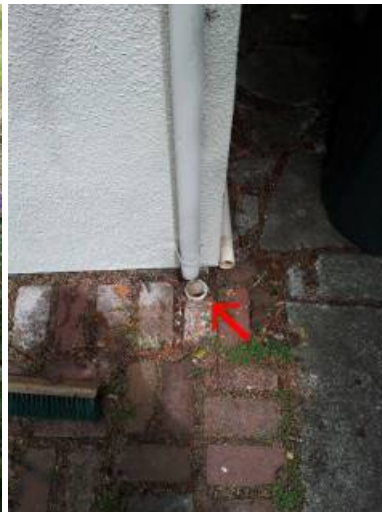
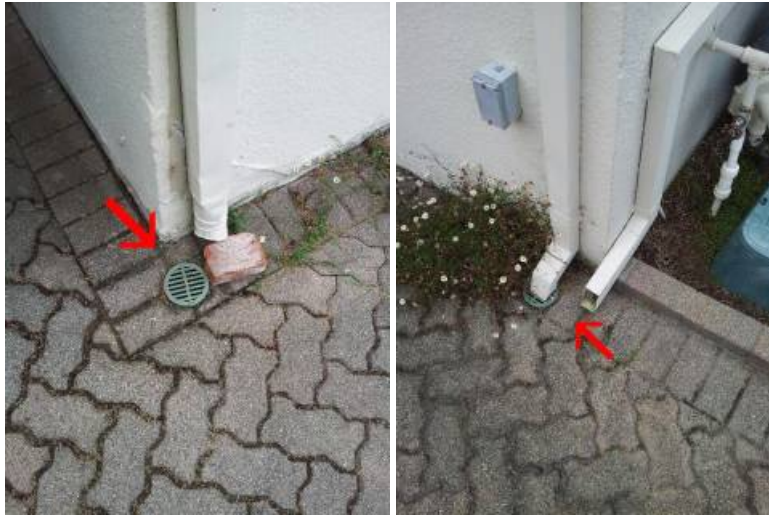
Gutters & Downspouts:

One or more downspouts route to underground drainage. The effectiveness of this system was not evaluated as that determination is beyond the scope of this inspection.

Other downspouts terminate at the foundation, and at the vicinity of the underground system. Recommend engaging a skilled tradesperson to evaluate the possibility of routing these downspouts into the underground system.

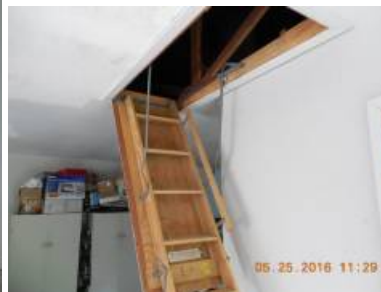
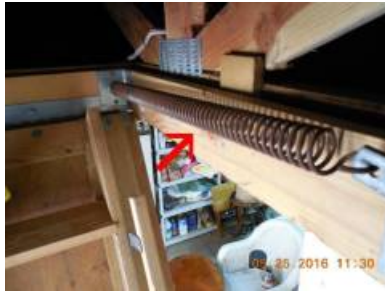
It was noted the springs on the access ladder for the garage did not have safety wires installed. As a safety upgrade, recommend installation by a skilled tradesperson.

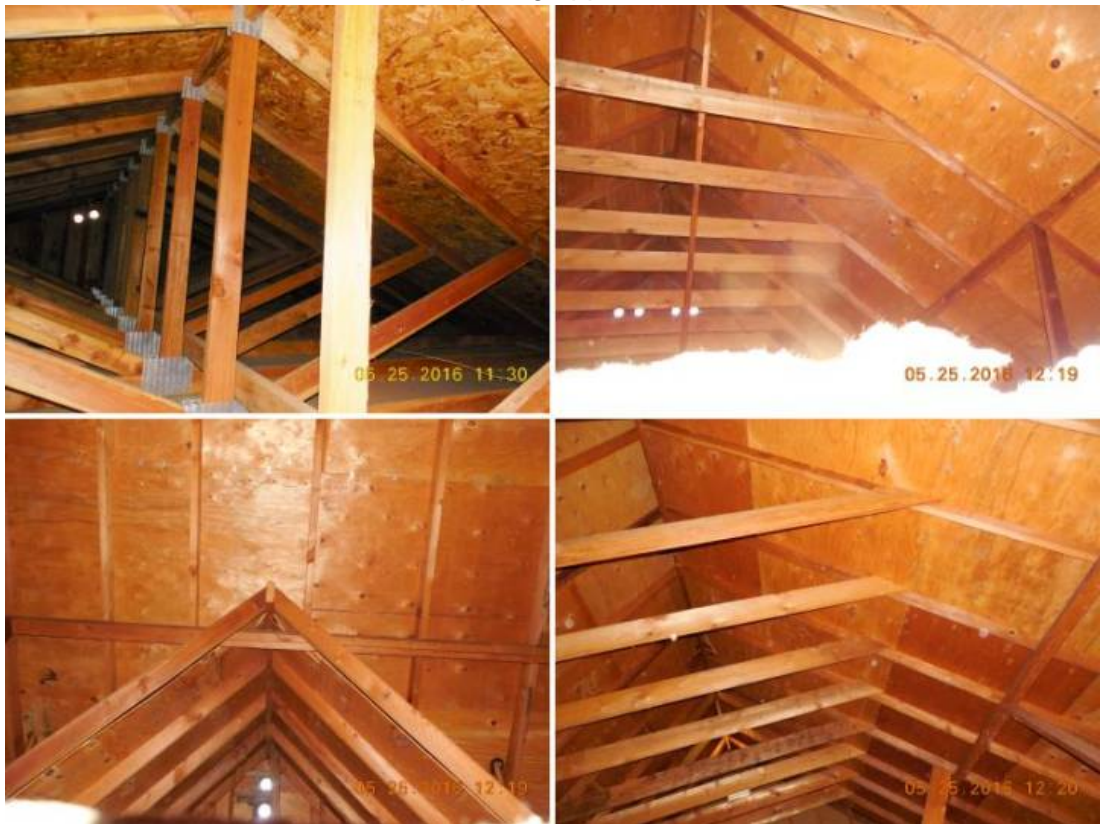
Structure:

A rafter system is installed in the attic cavities to support the roof decking. The rafter system appears to be in satisfactory condition. The rafter spacing appears ~ 24 inch on center.

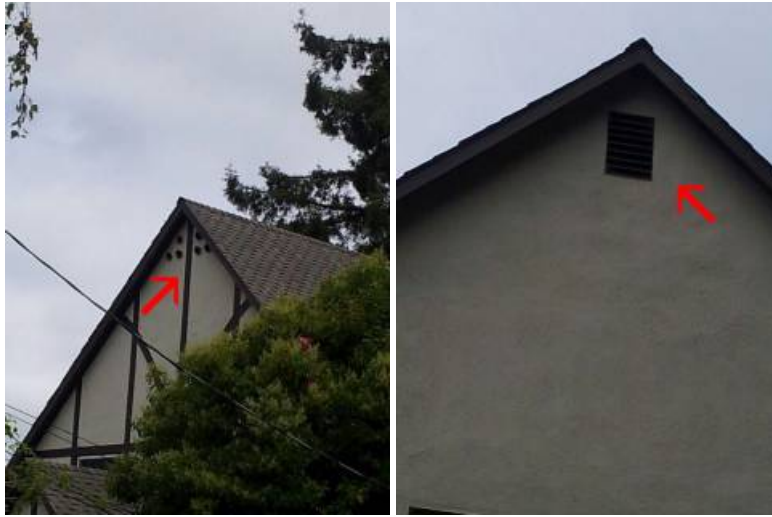
Ventilation:

Appears to be satisfactory. Gable end vents were observed.

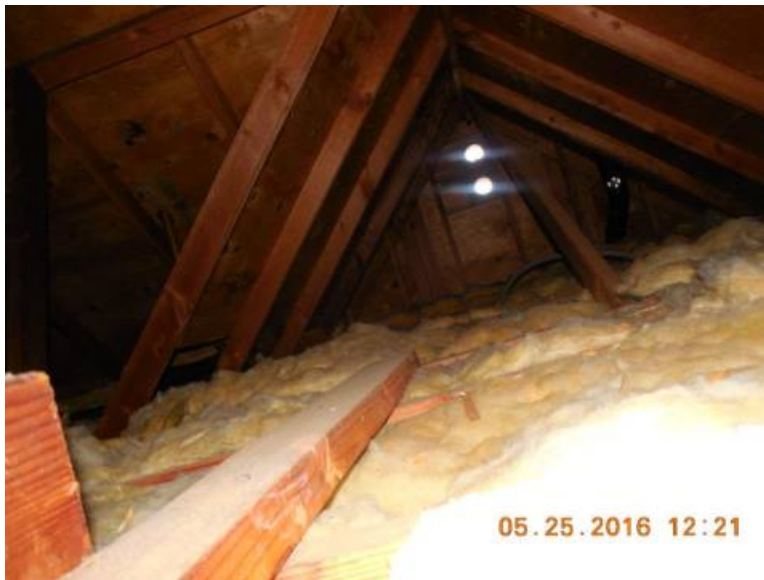
Insulation:

Insulation is installed between the joists in the house attic.

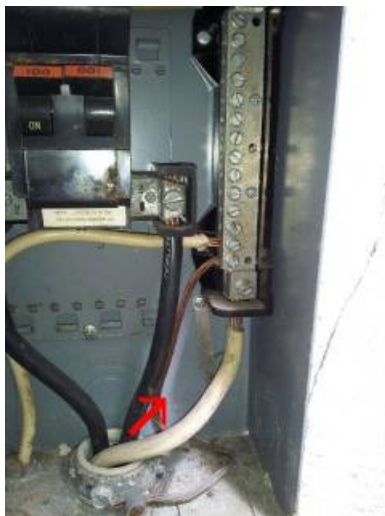
Service:

Evidence of ground was observed in the main electrical panel, however attachment to a ground rod or rebar in the garage was not observed. Recommend engaging a licensed electrician to verify proper ground.

OK	MM	RR	SAF	NI	
Type & Condition:	<input checked="" type="checkbox"/>	<input type="checkbox"/>	<input type="checkbox"/>	<input type="checkbox"/>	<input type="checkbox"/>	Service is 100 amp, 110/220 Volts, with circuit breakers.
Grounding Equipment:	<input type="checkbox"/>	<input checked="" type="checkbox"/>	<input type="checkbox"/>	<input type="checkbox"/>	<input type="checkbox"/>	Evidence of ground was observed in the main electrical panel, however attachment to a ground rod or rebar in the garage was not observed. Recommend engaging a licensed electrician to verify proper ground.

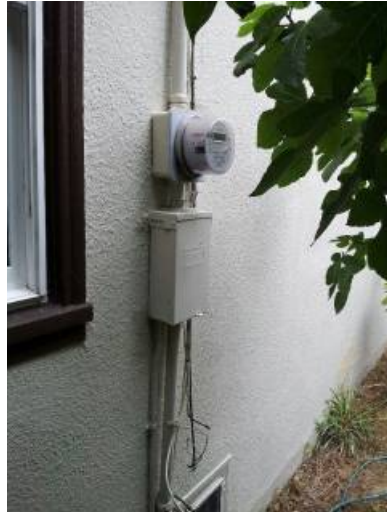
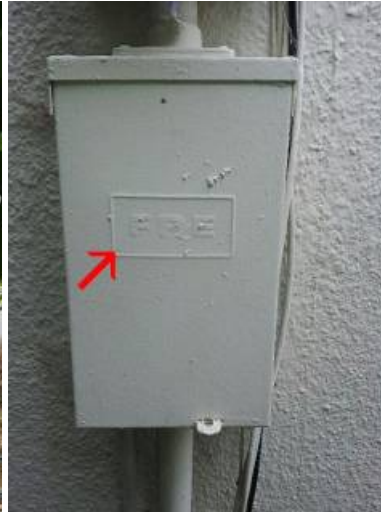
Main Panel Location:

Exterior of house on the right front area, 3 foot clear access is provided. Weatherproof and secure.

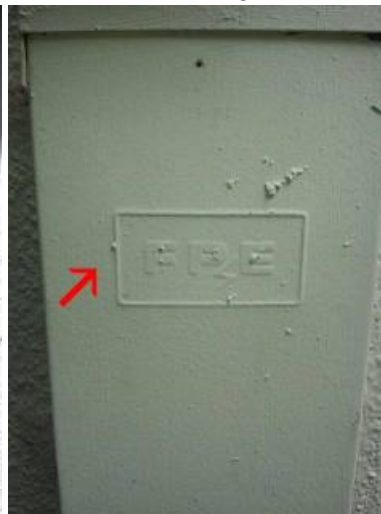
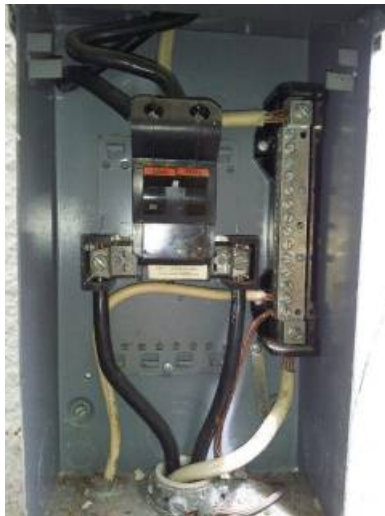
Main Panel Observations:

It was noted that this panel is a Federal Pacific Electric panel. There have been recalls for this type of panel due to overheating. This is a safety concern. Recommend engaging a licensed Electrician to further evaluate, make recommendations and implement repairs as required.

The main disconnect is located here. Circuit and wire sizing correct so far as visible, no evidence of over heating.

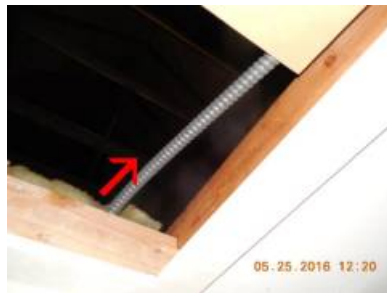
It was noted that an electrical cable was routed over the access hatch in the house attic. This is a safety concern. Recommend engaging a Licensed Electrician to reroute.

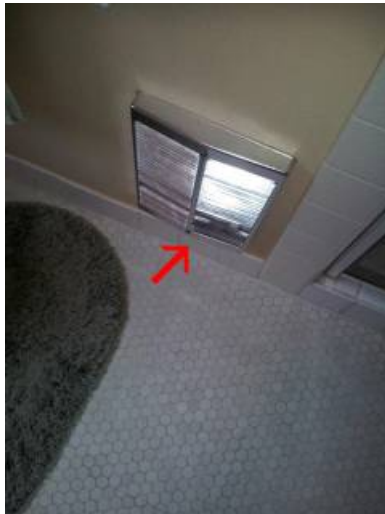
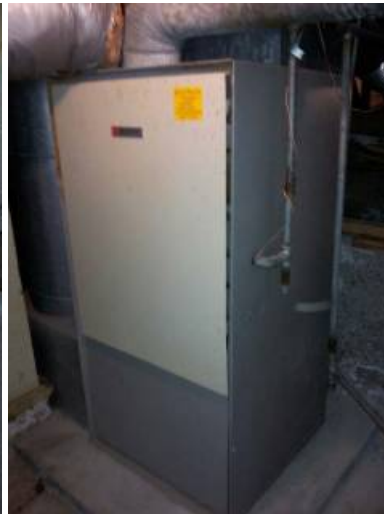
Type & Location:

Forced air located in the basement. Also, an electric wall heater in the first floor bathroom.

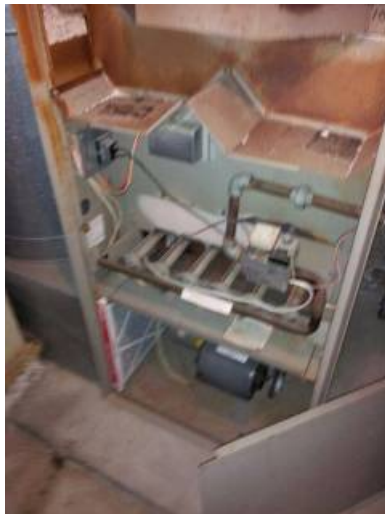
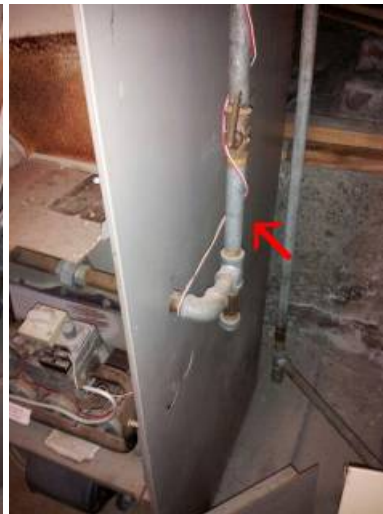
General Operation & Cabinet:

The furnace operated appropriately with no unusual noises.

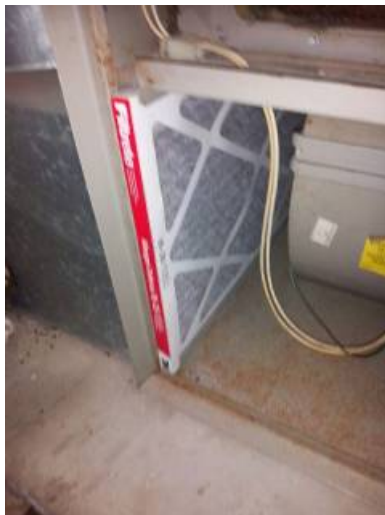
- Air Filters:** Replacing or cleaning filters every 60-90 days is recommended.

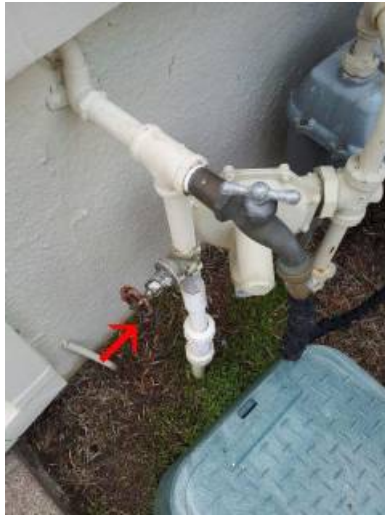
Shut Off: The main shutoff valve is located on the left side.

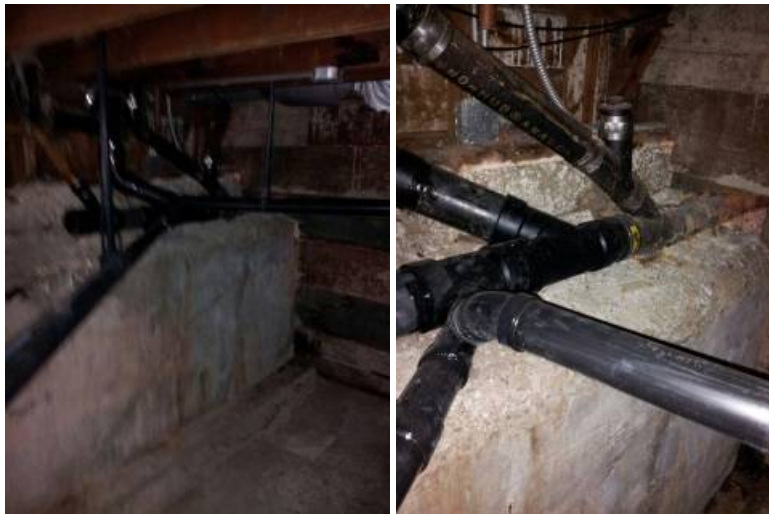
Material:

Cast/ABS waste system, appears serviceable.

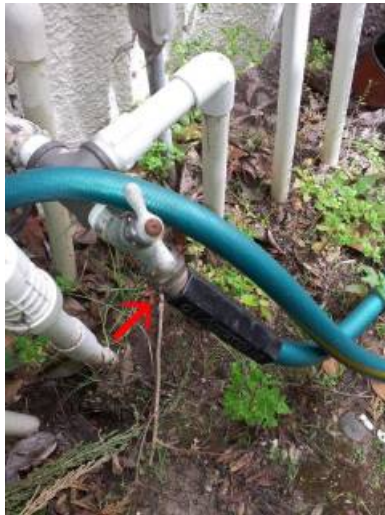
Back flow prevention device recommended at all bibs. This small attachment available at hardware stores prevents water from being drawn back into the inside in the event of a pressure drop.

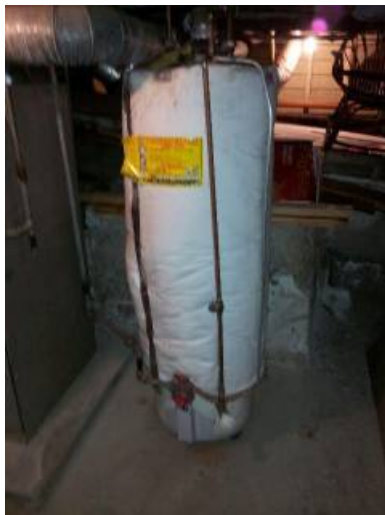
Location:

In the basement.

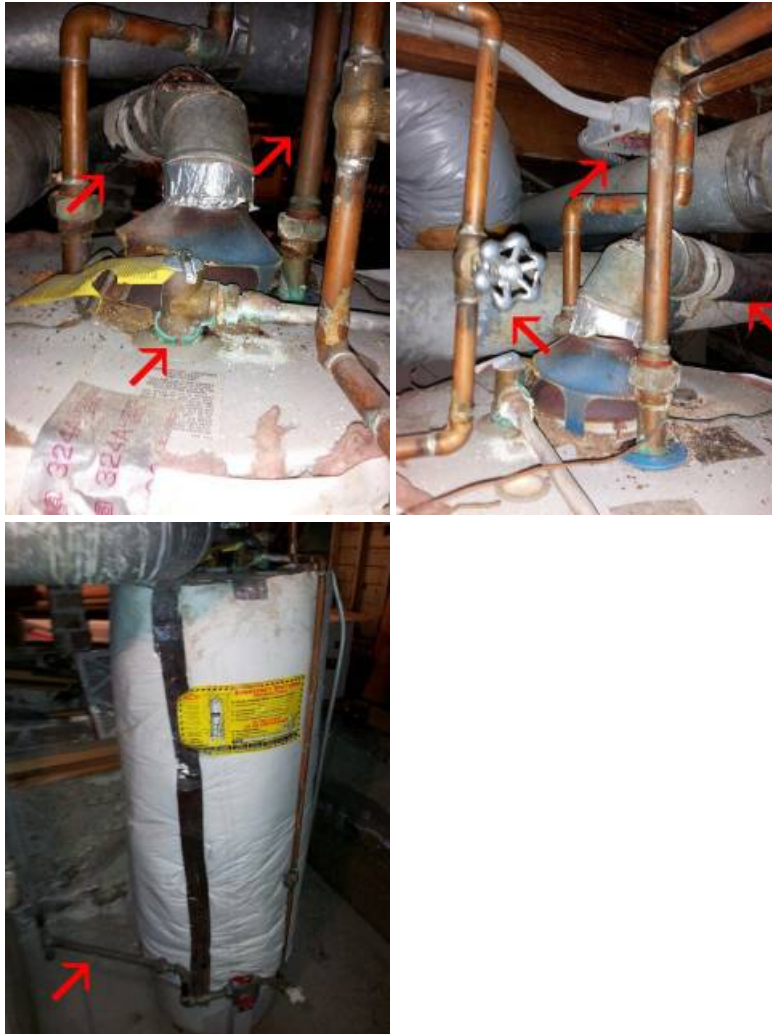
Condition:

There are a number of concerns with the installation. No seismic safety straps were installed. The flue vent sloped downward. There are no flex water lines leading to the heater. There is no flex fuel line installed. These are safety concerns. Recommend engaging a licensed Plumber to further evaluate and repair as required.

The owner advised a Plumber was scheduled the day following the inspection.

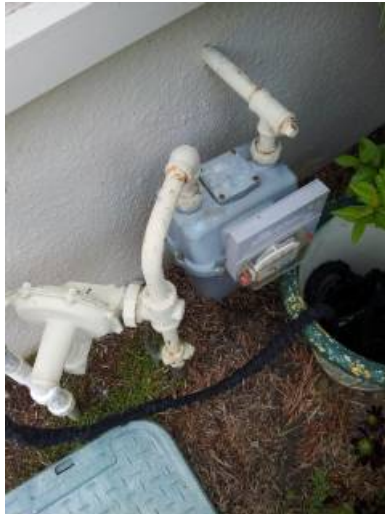
Meter located at exterior, System appears serviceable.

Recommend installing a fuel shutoff wrench at the meter.

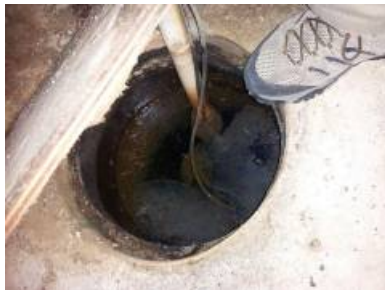
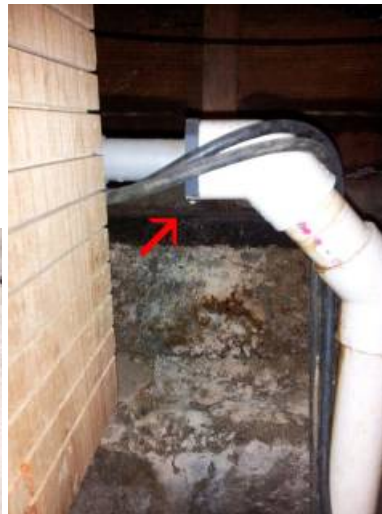
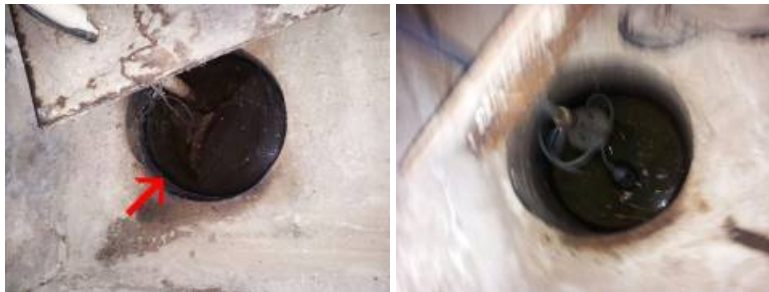
Sump Pump:

Three sump pumps and pits observed. Two at the front corners and one at the rear. The right front pump operated, and a leak in the piping was noted. The left front was unplugged, and the rear float did not activate due to limited water level.

Recommend engaging a skilled tradesperson to bring the left front pump to operation, and repair the leak in the pipe at the right front.

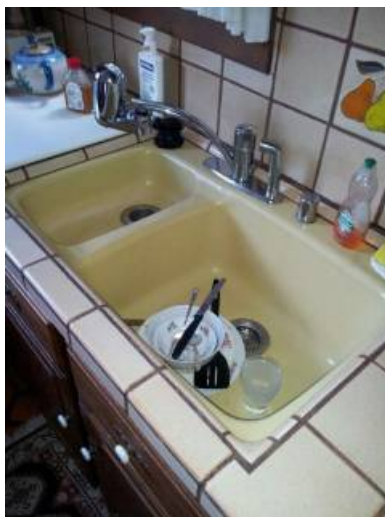
Kitchen Sink:

Porcelain sink, Faucet is serviceable, Hand sprayer is serviceable. Sink drains appropriately.

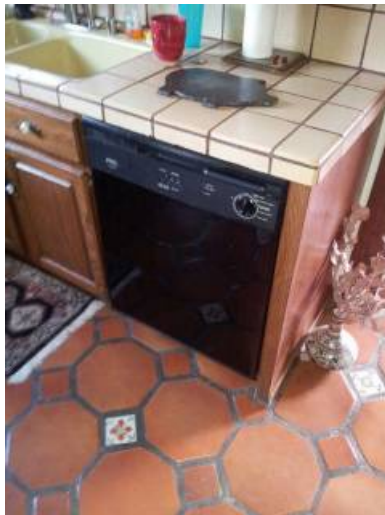
This unit appears serviceable, door hinges ok. soap dish opened upon operation. The air gap was present and operated appropriately.

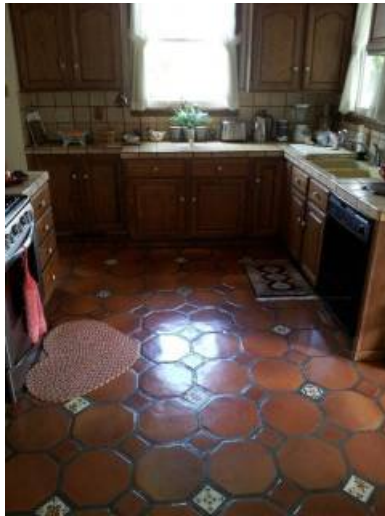
Counters & Cabinets:

Tile counters are in serviceable condition.
Cabinets appear serviceable.

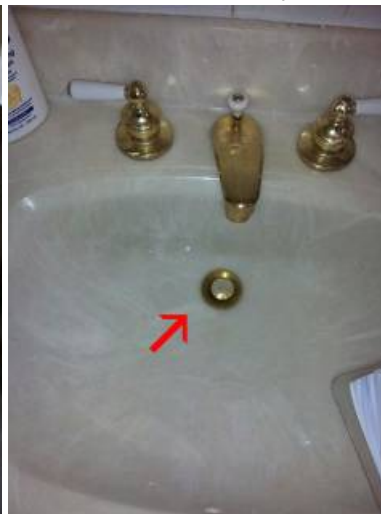
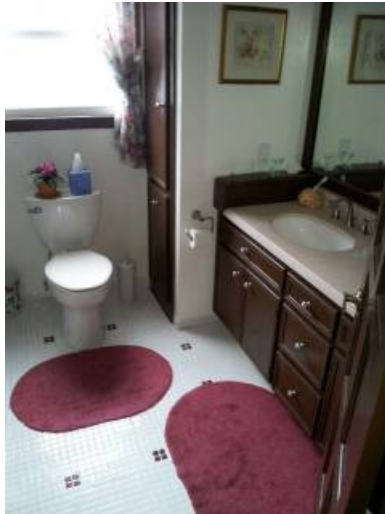
The first floor sink drained slowly. Recommend engaging a skilled tradesperson to repair as required. The owner advised a Plumber was scheduled the day following the inspection.

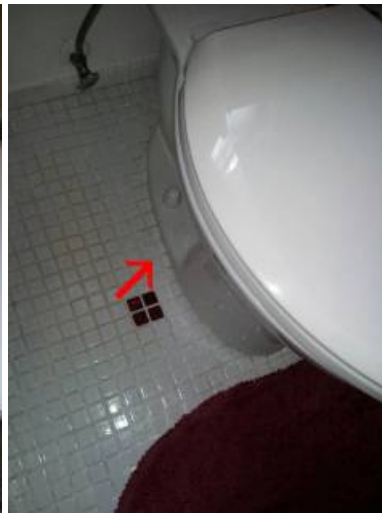
The toilets flushed appropriately. Both toilets were loose. Leakage below the floor was not determined. Recommend engaging a skilled tradesperson to secure as required. The owner advised a Plumber was scheduled the day following the inspection.

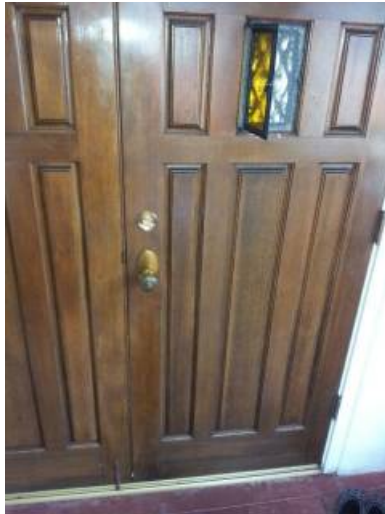
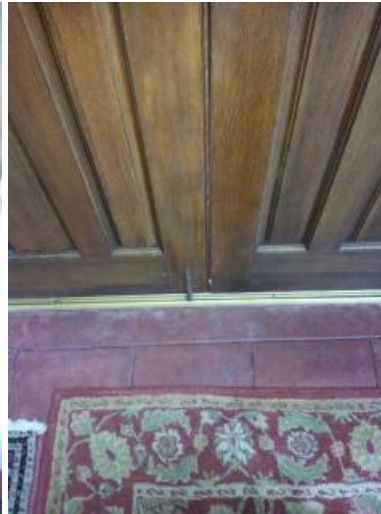
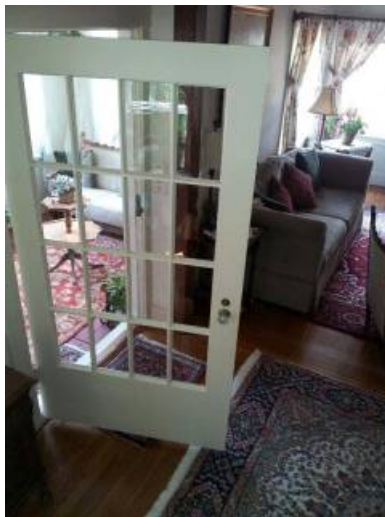
Main Entry Door:

Wood construction with appropriate weather stripping, minor adjustment required at the bottom. Hardware operated appropriately.

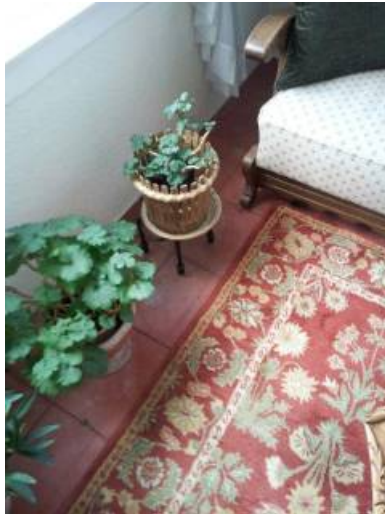
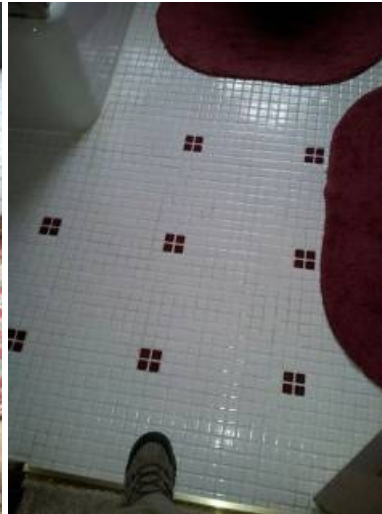
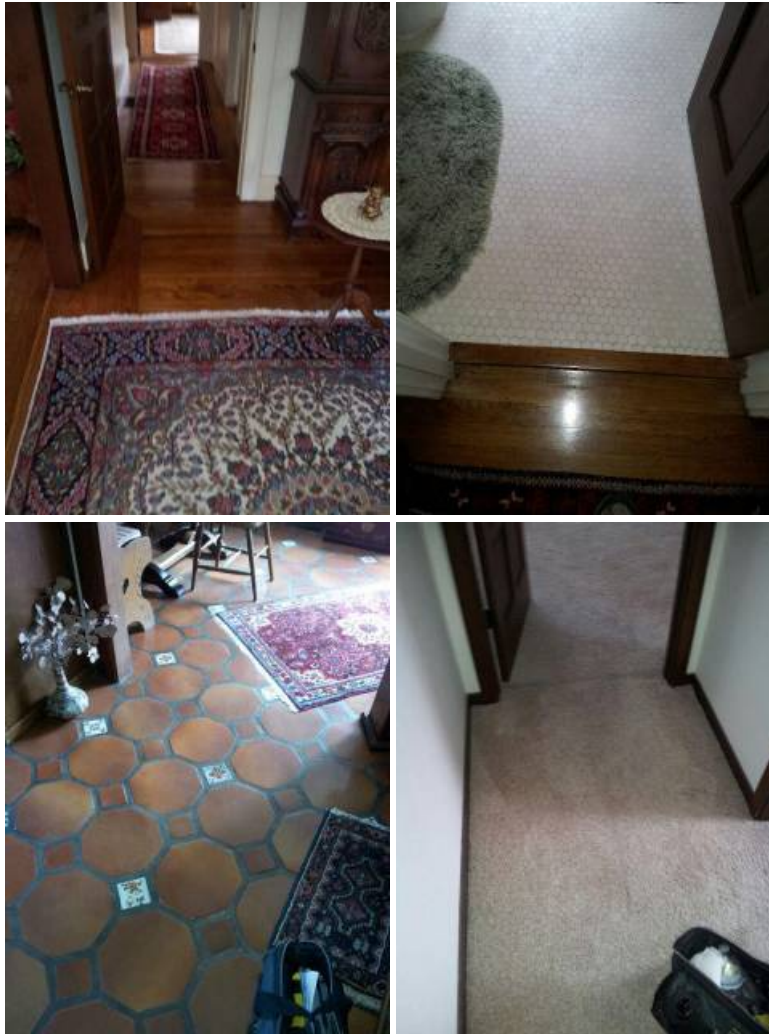
A combination of hardwood, wall to wall carpeting, and tile flooring was present and appeared in serviceable condition.

Minor subfloor sounds noted on the second floor.

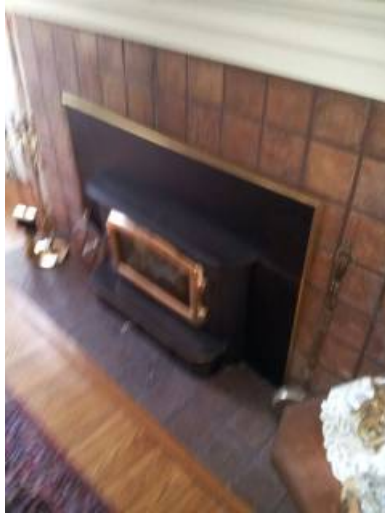
Wood Burning Fire Place:

Pellet stove noted in the fireplace. Not a part of this inspection.

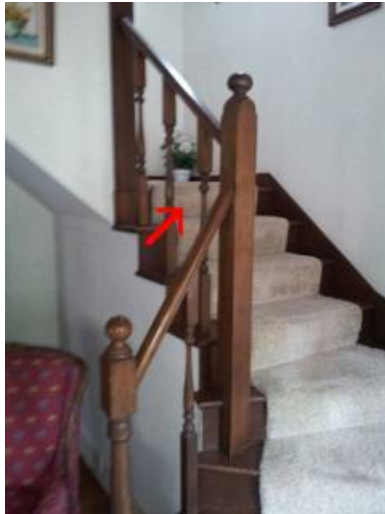
The stairs and handrails were secure, however, do not meet current recommendations for baluster spacing and closed handrails. As a safety upgrade, recommend considering retrofitting to meet current requirements. Recommend engaging a skilled tradesperson to further evaluate make recommendations and implement.

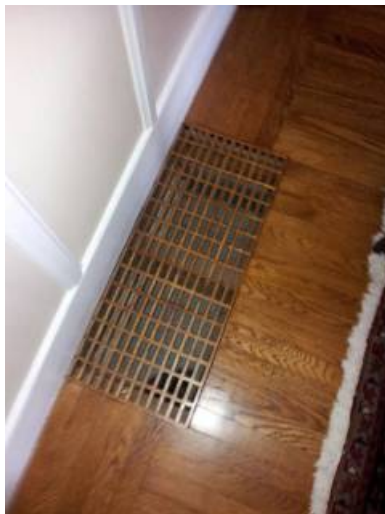
Duct Work/Distribution

Floor registers were present and operated appropriately. Rerturn register located in the dining room. Ducts were flexible round and appear serviceable.

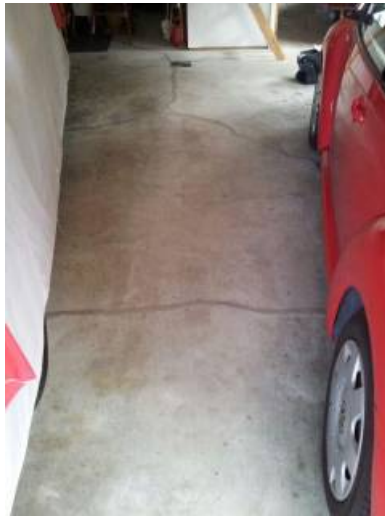
Floor:

Appears in serviceable condition. Sealed cracks noted.
